**Report No. SFIM -AEC-ET-CR-98020  
FINAL REPORT**

## **Replacing or Retrofitting Oil/Water Separators A Case Study at Fort Lee, Virginia**

**July 1998  
Contract No. DACA31-96-D-0082  
Delivery Order No. 0001**

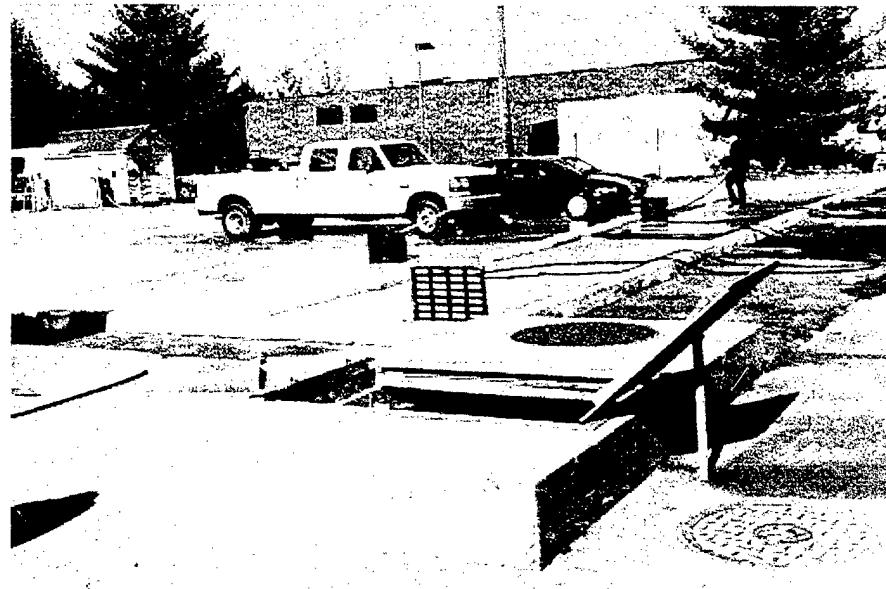
The study team observed that each of the new OWS with coalescing tube packs at Ft. Lee, were designed and equipped with small (1ft x 2ft) manways (hatches) on top for access to the internal chamber (see Photo 3-1). Because of the relatively small size of these hatches, it was virtually impossible to adequately access the central chamber and to pull out the coalescing tube packs from these OWS either for study or routine purposes. On the other hand, as indicated in Photo 3-2, the TMP's retrofitted OWS had large metal door panels, allowing easy access into the central chamber for installation and removal of the coalescing tube pack assemblies.

**Photo 3-1.** Pre-constructed OWS installed at a new motor pool washrack location. All the new OWS were equipped with small manways, inhibiting access to the internal chamber and removal of the coalescing tube packs.

Construction of OWS with coalescing media must include large enough openings to allow for complete access to and removal of the coalescing media assembly or components. The 1'x 2' manways are not adequate for this purpose.

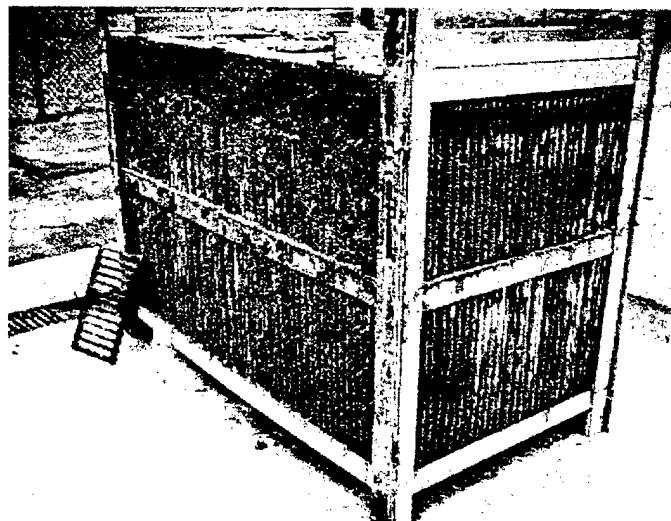
**Photo 3-2.** OWS at TMP site with its door panels open. All the retrofitted OWS were equipped with similar door panels, allowing easy access to the coalescing tube packs.
